**SGS Germany GmbH**  
**Wind Energy Services**  
**Proactive Maintenance Concepts**

*“ Vorwegnehmende Instandhaltung von Windenergie-  
anlagen“ 10./12. November 2015*

# proactive maintenance concepts

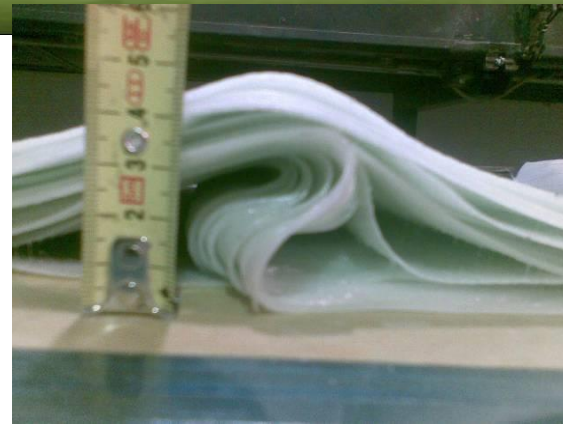
Wrinkled, undulated glass  
fibres are weak points in GFRP  
(Glass Fibre Reinforced Polymers)  
Materials/structures subject to  
fatigue loading

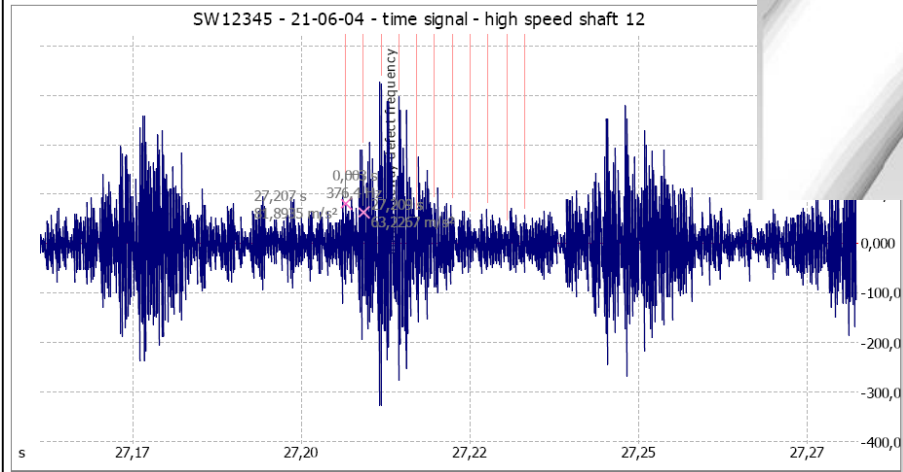
high speed shaft bearing 2 █ Alarm

The time waveform of the measurement 'high speed shaft 12' shows pulses w of the inner raceway defect frequency of the non driven high speed shaft bear be an indication for an inner race defect.

The inner race of the bearing is seriously damaged. The bearing has to be replaced to avoid further defects.

The time waveform of the measurement 'high speed shaft 12' shows pulses with a distance of the inner raceway defect frequency of the non driven high speed shaft bearing. This could be an indication for an inner race defect.

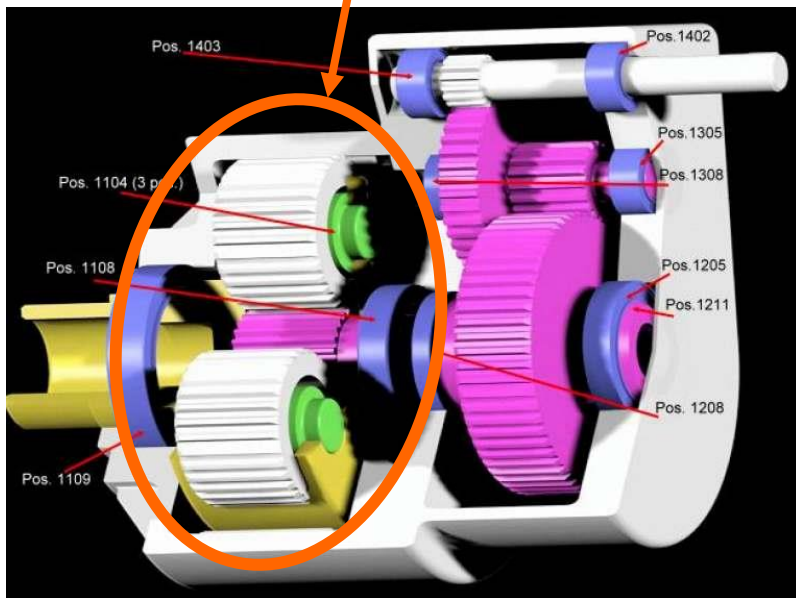
Damage detection in planetary stage supported by oil analysis

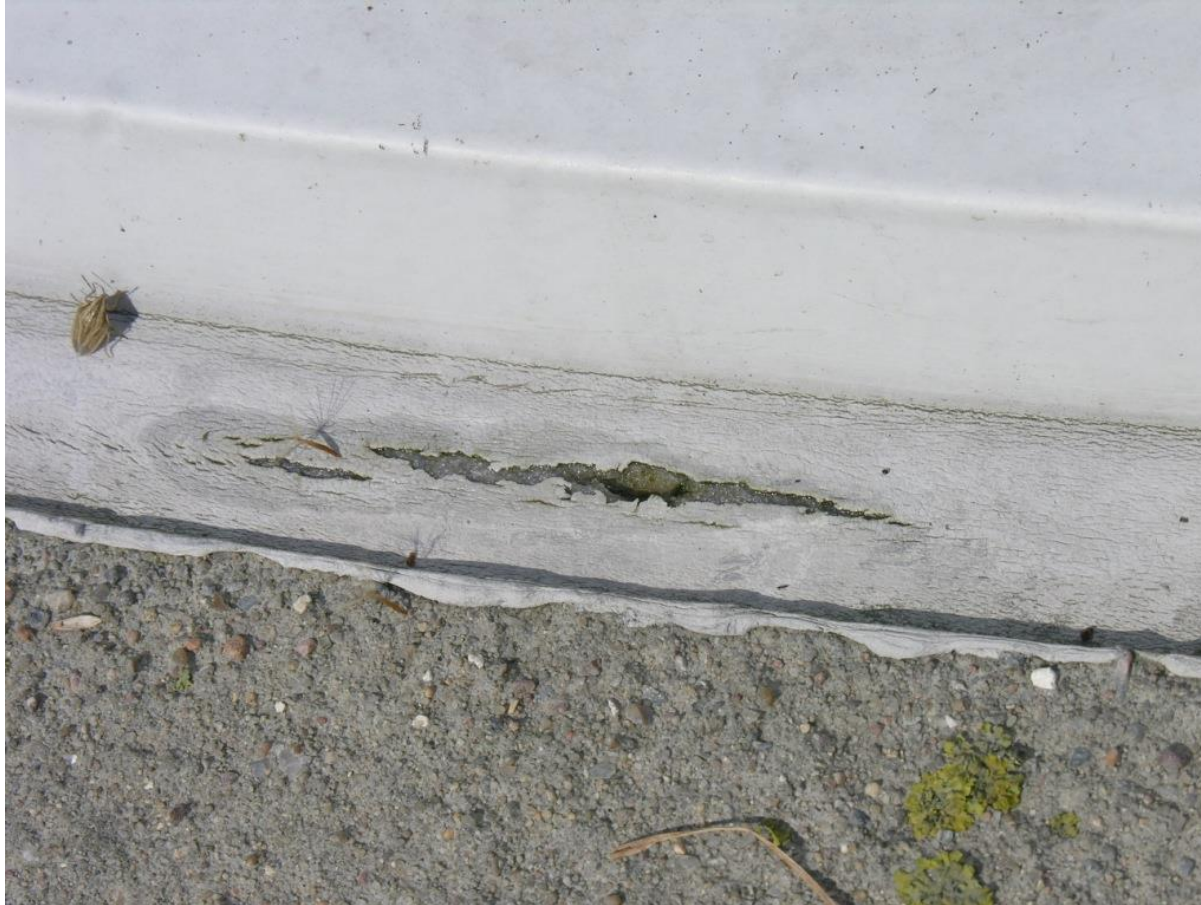
**Improper sealing**

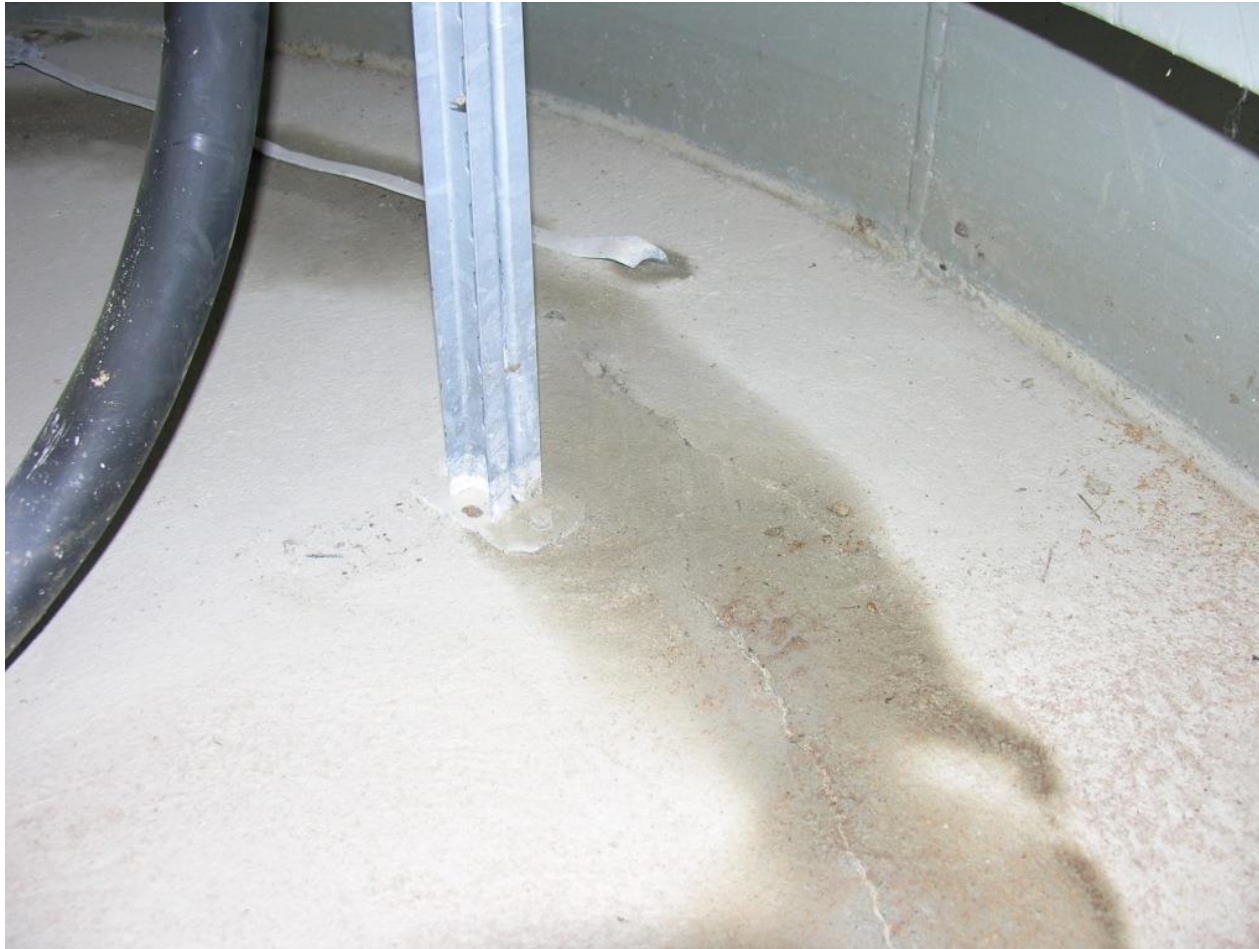
**Cracks inside  
cast down  
part**

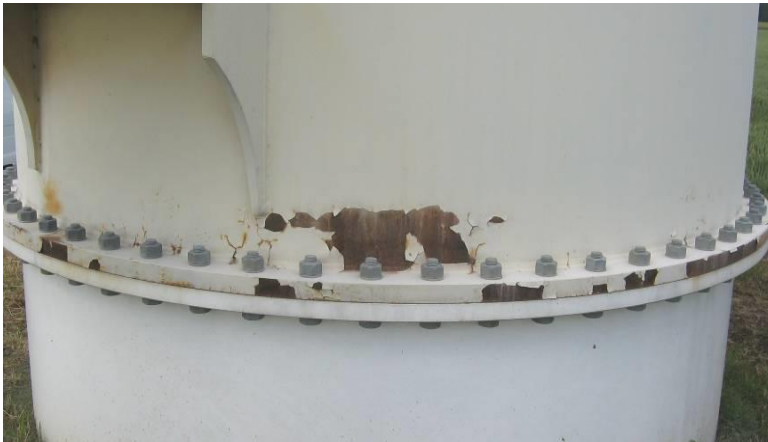
## Defect painting

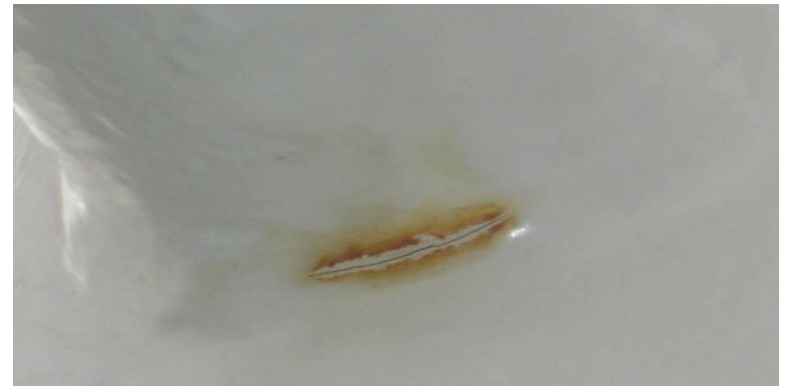
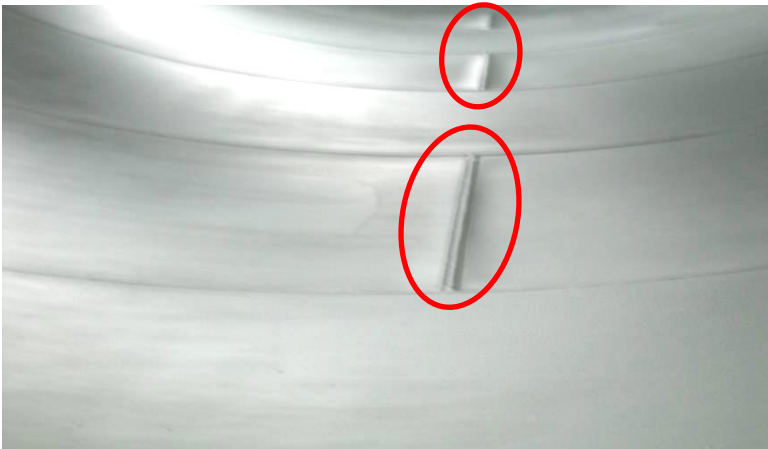
## Corrosion

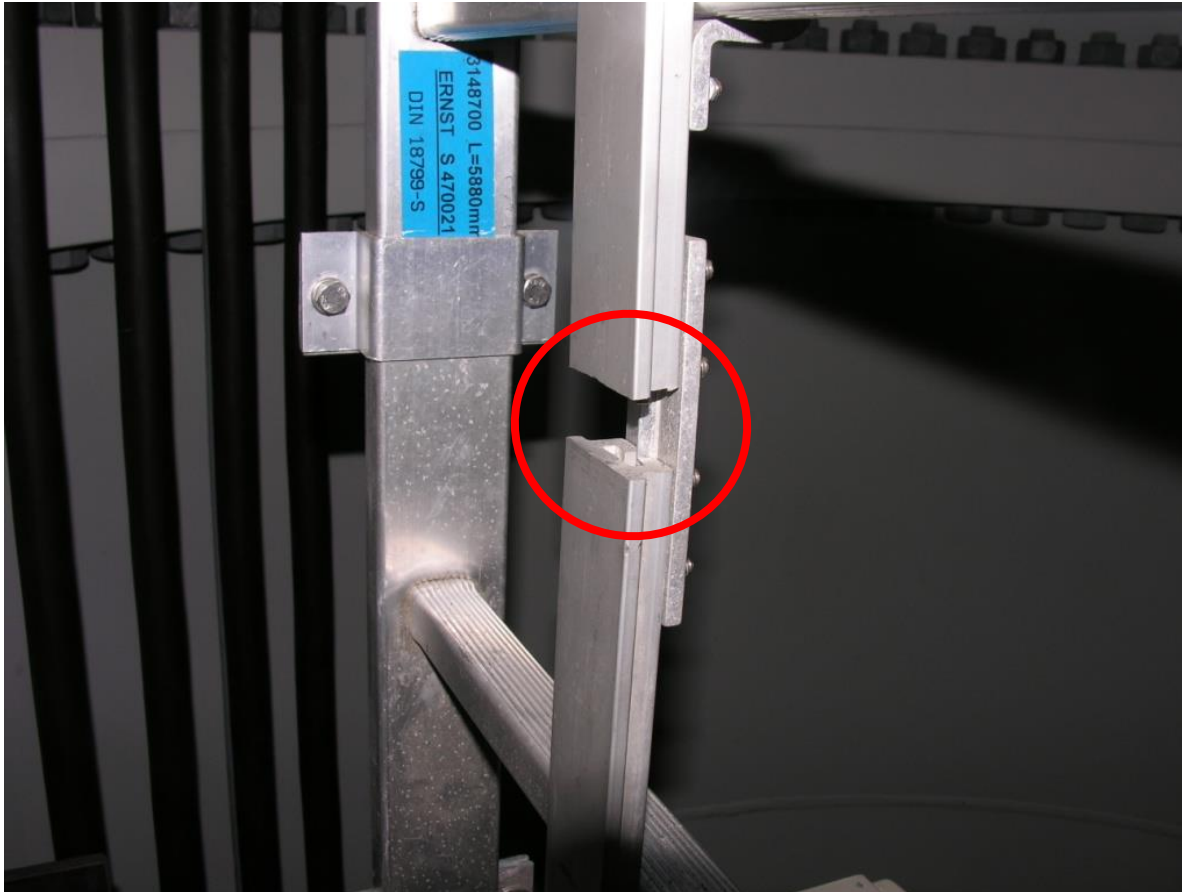
**Safety rail mounting**

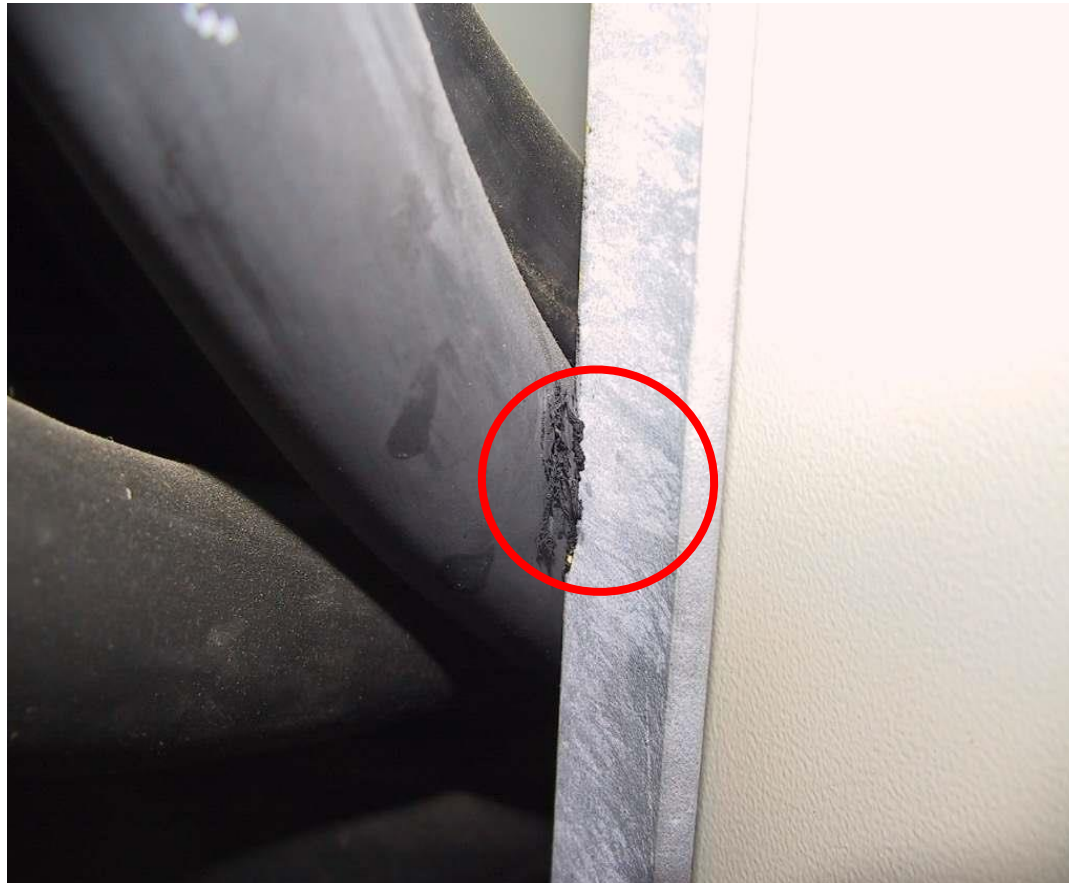
**Cables worn on  
panel frame**

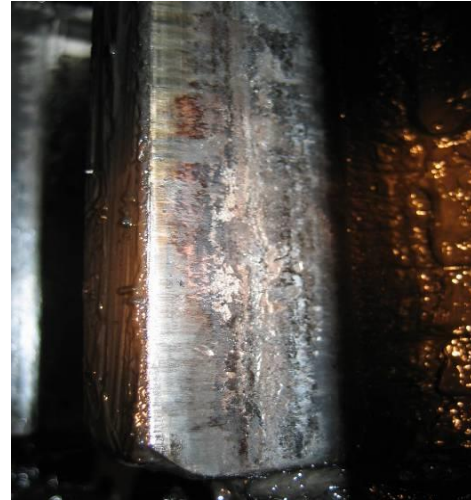
**Corrosion**

**Macro pitting**

**Broken teeth**

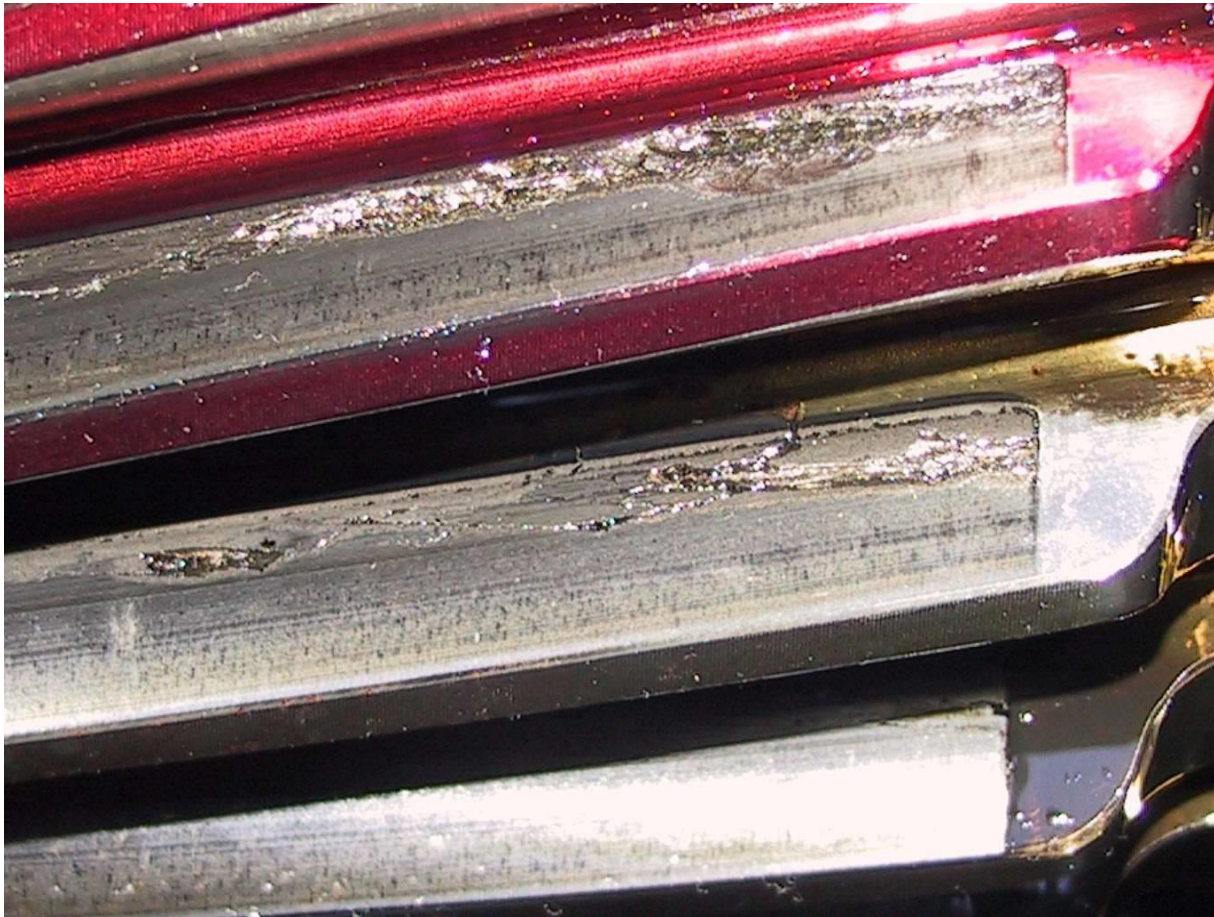
**Macro pitting**

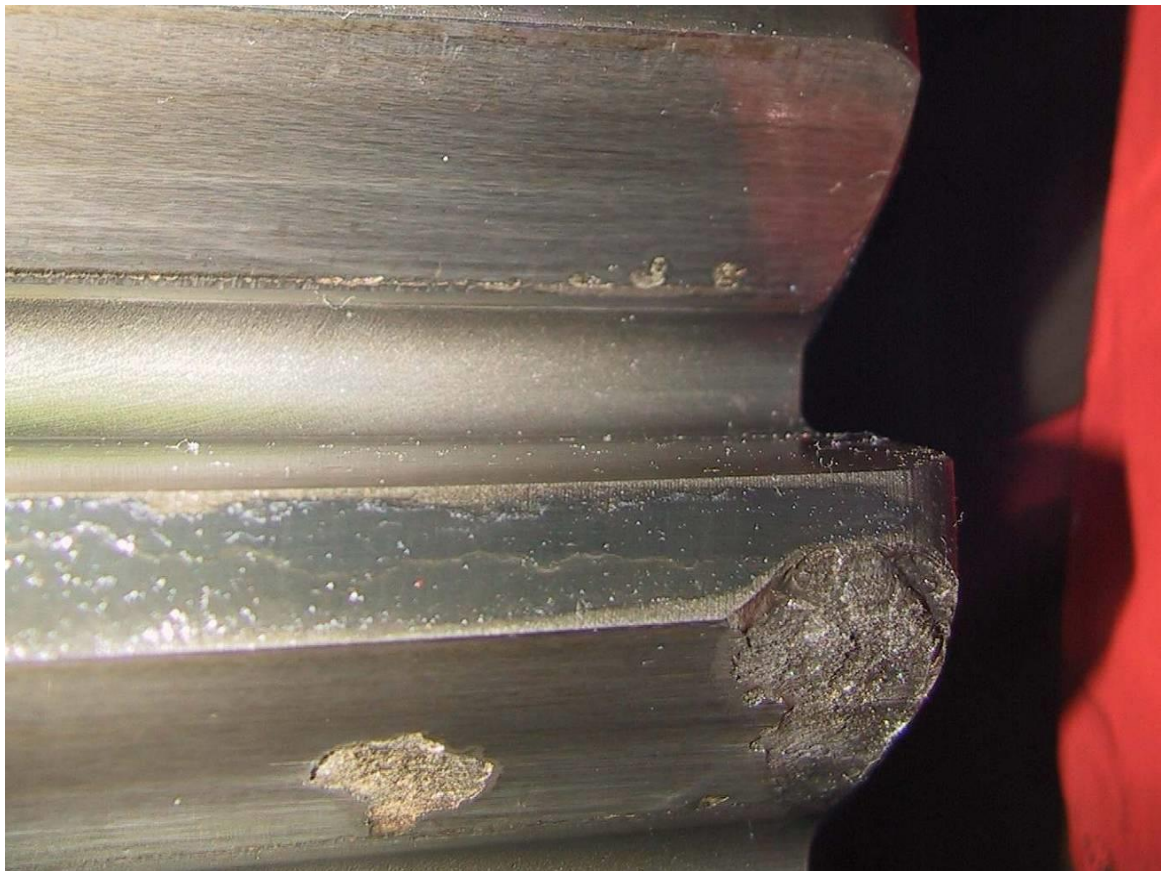
**Macro pitting**

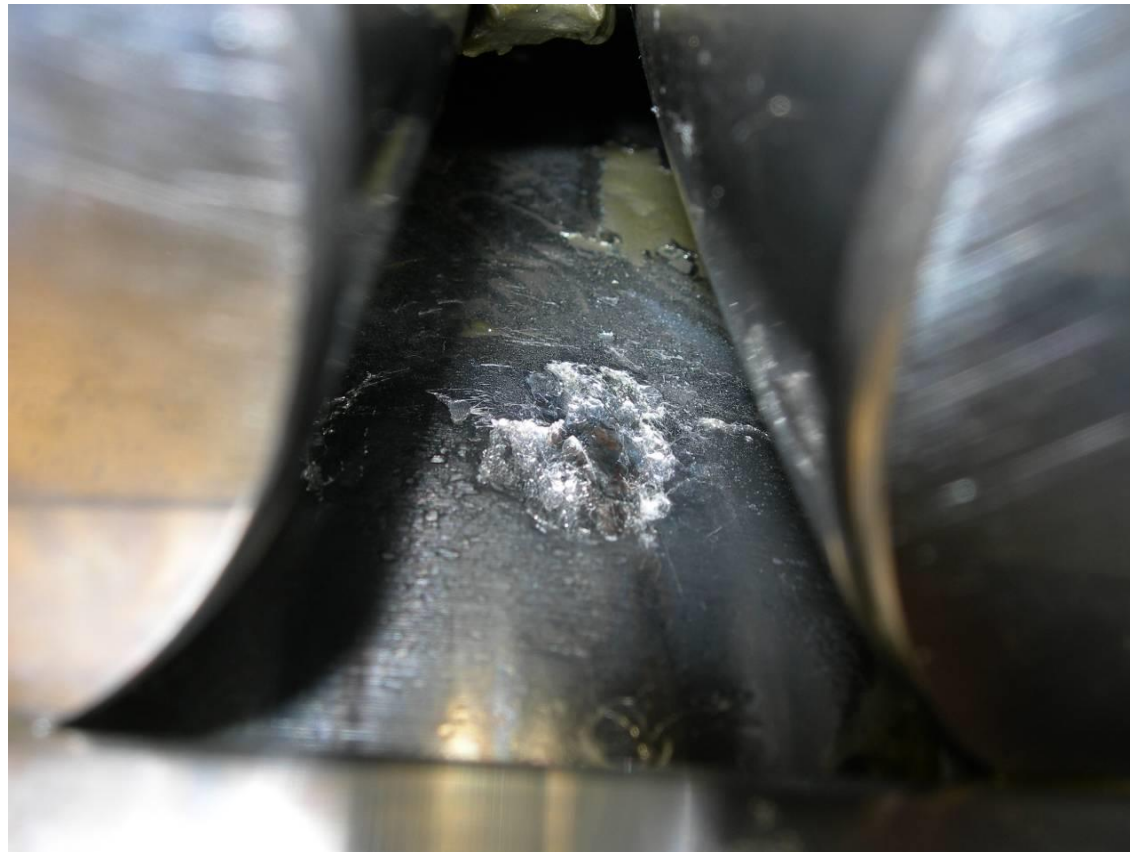
**Scaling on inner race**

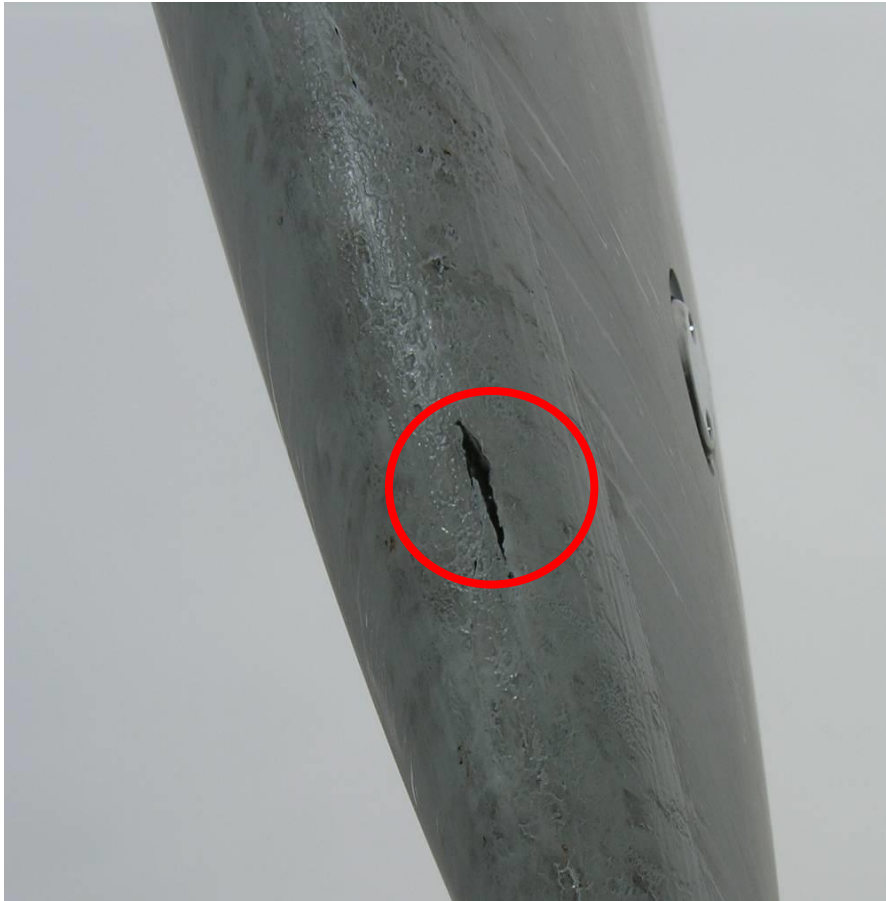
Air pocket due to improper glue filling

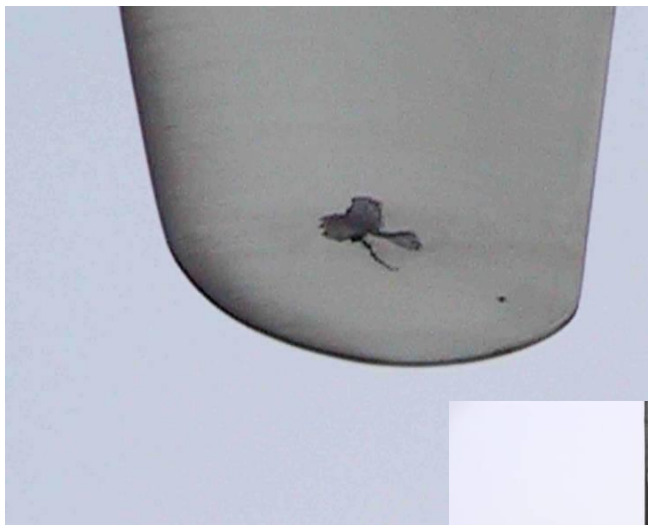
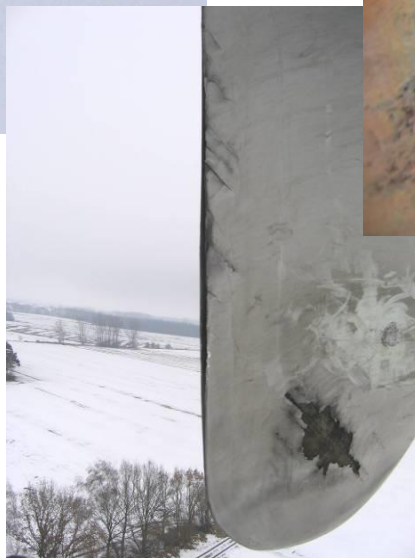
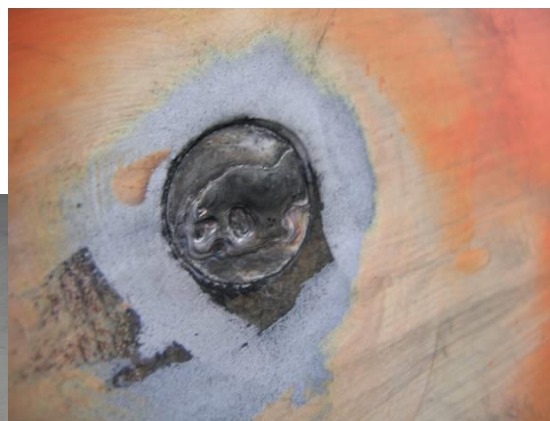
Damages from lightning stroke
